# **EXHIBIT K**

# Materials Characterization of Explanted Polypropylene Hernia Meshes

C. R. Costello, S. L. Bachman, B. J. Ramshaw, S. A. Grant

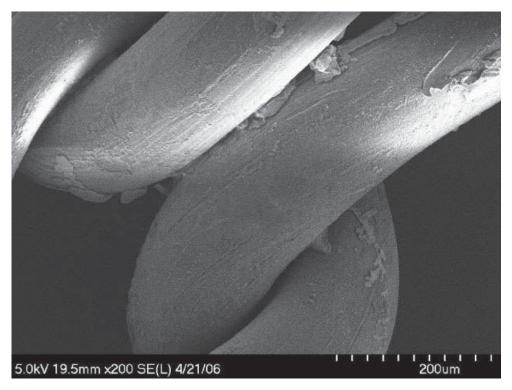
such as cracks or fissures. Conversely, as shown in Figures 5–7, the explanted polypropylene specimens appeared badly degraded, including cracks, fissures, and increased surface roughness. Micrographs of 79% of all explanted specimens exhibited cracks in the transverse or longitudinal direction, 57% showed what appeared as a peeling of the fiber surface, and 64% displayed a rough, blistered surface. Overall, 85% of the explanted specimens possessed at least two or more of these types of surface structures.

The SEM micrographs displayed images of materials that were vastly different in topology than the pristine materials. The micrographs of explanted polypropylene materials exhibited cracks, surface roughness, and peeling indicative of surface degradation, 6,10,12 while the pristine materials appeared smooth.

Figure 7. SEM of an explanted polypropylene mesh with "peeling" fibers.
